SERVICE BULLETIN

DOCUMENT No. 1100141 Rev. 00

- RH POWER JUNCTION BOX -

REPLACEMENT OF IDENTIFICATION LABEL FE1549R-02

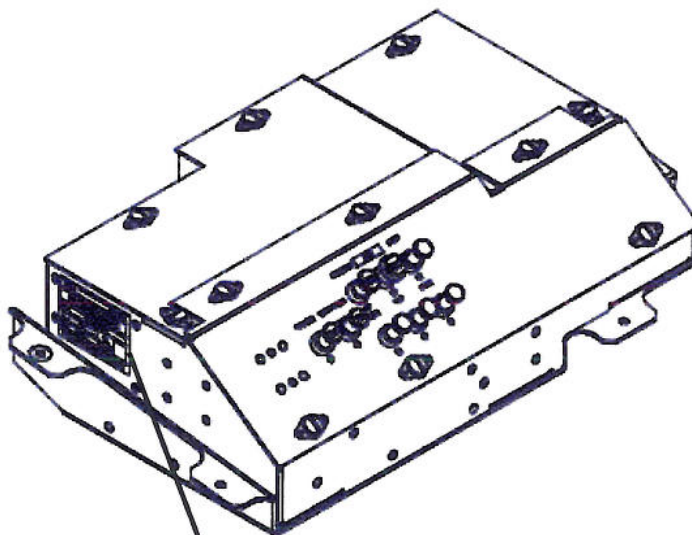
Change of identification label on RH Junction Boxes for all affected Parts due to wrong identification label.

- (1) Remove the identification label
- (2) Clean the area
- (3) Put the correct identification label with PILATUS part N°:974-03-38-143
- (4) Keep the initial Serial Number (S/N) and Date Code (D/C)

Check that the identification label is correctly installed
